# Explore the Site

# Crib Dam

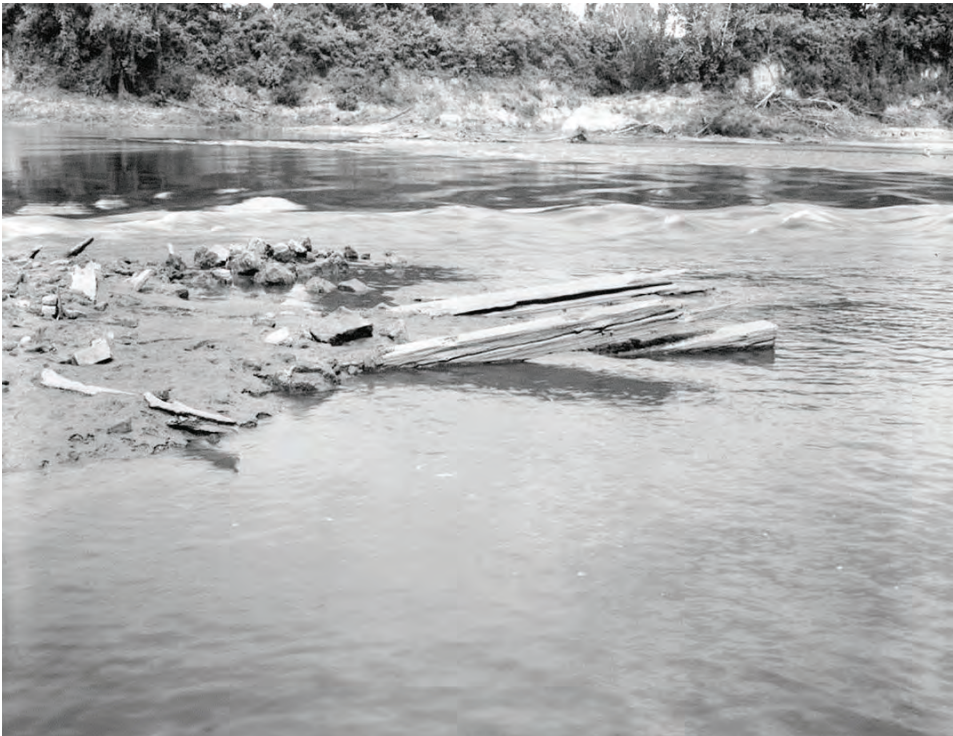
*(Above) Closeup view of exposed crib timbers from crib section of Lower Bailey's Dam, facing northeast. Courtesy of the Library of Congress: HAER LA, 40-ALEX. V,2-16.*

Archaeologists exposed the remains of the cribs at the lower (main) dam. The historical drawing showed the cribs as built of logs and filled with stones. Historical accounts said that the cribs were constructed of lumber from buildings and that machinery, stone and brick filled them. The archaeologists confirmed the written records that said the framework of the cribs was hewn timbers from buildings. However, archaeology showed that the cribs had been filled with clayey sand, topped with stones and brick rubble. Archaeologists found an iron sugar kettle fragment in the crib area mixed among stone and brick pieces. The broken kettle may have been in, or on, a crib.

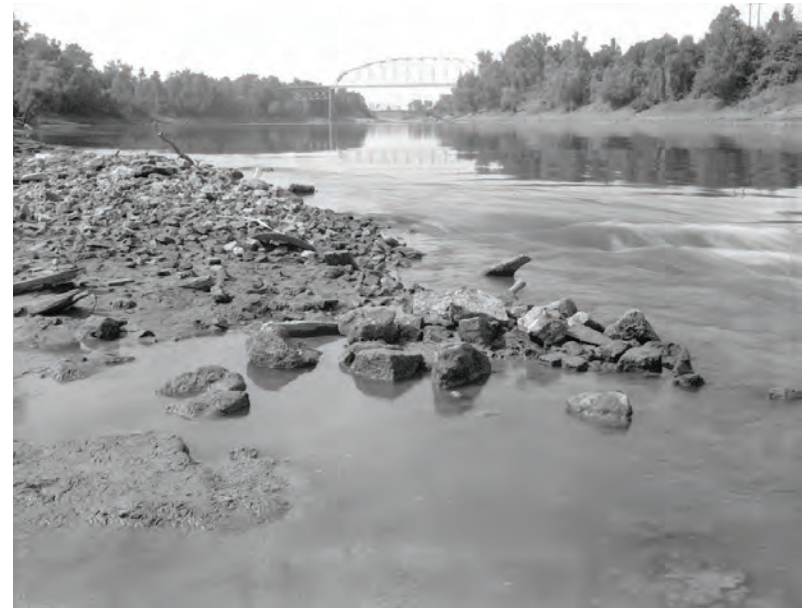
*(Top) Closeup view of sandstone boulder concentration in crib section of Lower Bailey's Dam, facing north. Courtesy of the Library of Congress: HAER LA, 40-ALEX. V,2-17.*

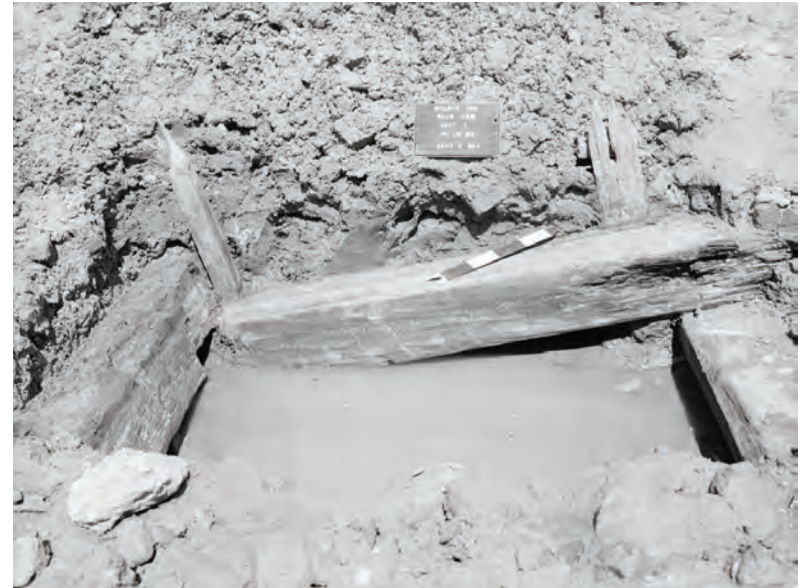
*(Bottom) View of crib section of Lower Bailey's Dam, facing northwest. Courtesy of the Library of Congress: HAER LA, 40-ALEX. V,2-21.*

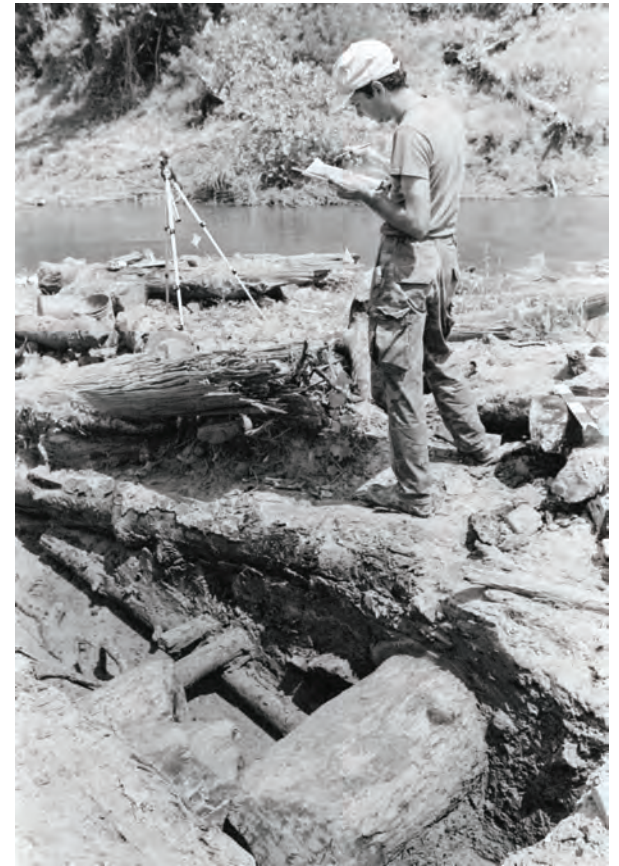
*(Top Right) Archaeologist drawing a map of logs uncovered during the tree dam excavations. Courtesy of Coastal Environments, Inc.*

Archaeologists dug a trench about 5 feet wide and 23 feet long to learn more about the tree dam. They found that the tree limbs had been cut off, unlike those in the historical picture. By observing the knots on the tree trunks, archaeologists could tell that many of the trees were positioned with their tops downstream. That was opposite of the design in the historical illustration. The tops of the trunks had been shaped into a point. Archaeologists found sand and mud between the logs, and brick and stone on top of them.

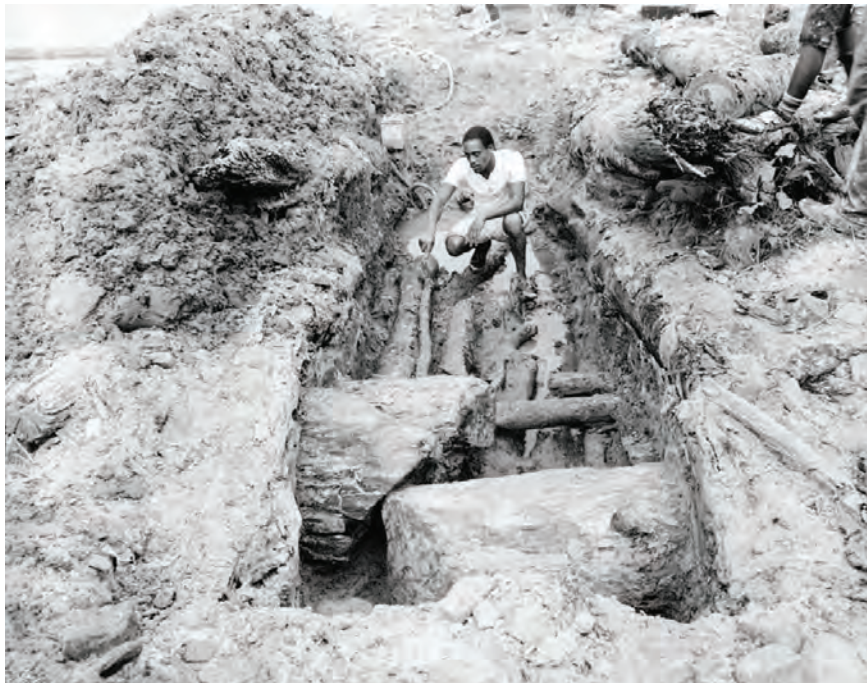
*(Lower Right) Closeup view of logs exposed in tree dam section of Lower Bailey's Dam, facing southwest. Courtesy of the Library of Congress: HAER LA, 40-ALEX. V,2-13.*

A 100-foot-long part of the tree dam at the lower (main) dam was clearly visible during times of low water in the 1980s. Archaeologists recorded parts of 146 logs that were above the water level, and others were just beneath the water. The logs were very well preserved. Brick and stone rubble was found piled on the upstream ends of the logs.

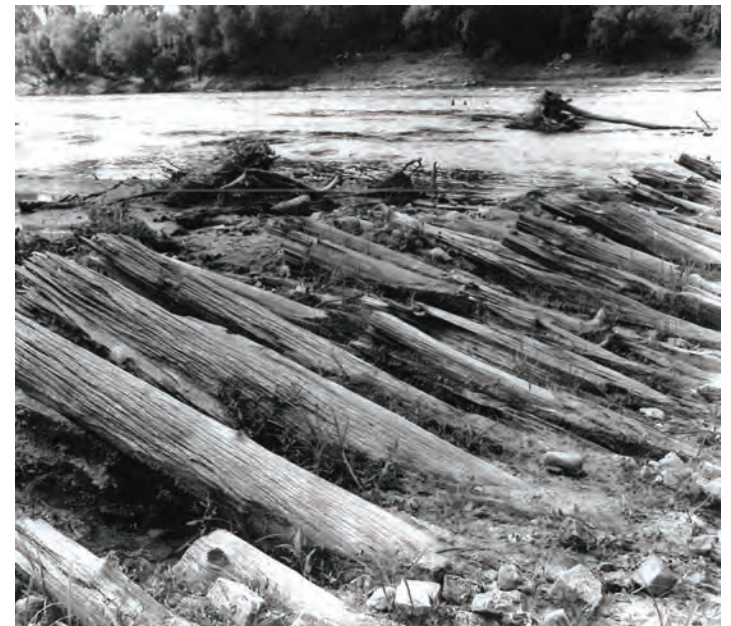
*(Left) Tree dam section of Lower Bailey's Dam. Third layer exposed with excavator perched on third log layer, facing northwest. Courtesy of the Library of Congress: HAER LA, 40-ALEX. V,2-19.*

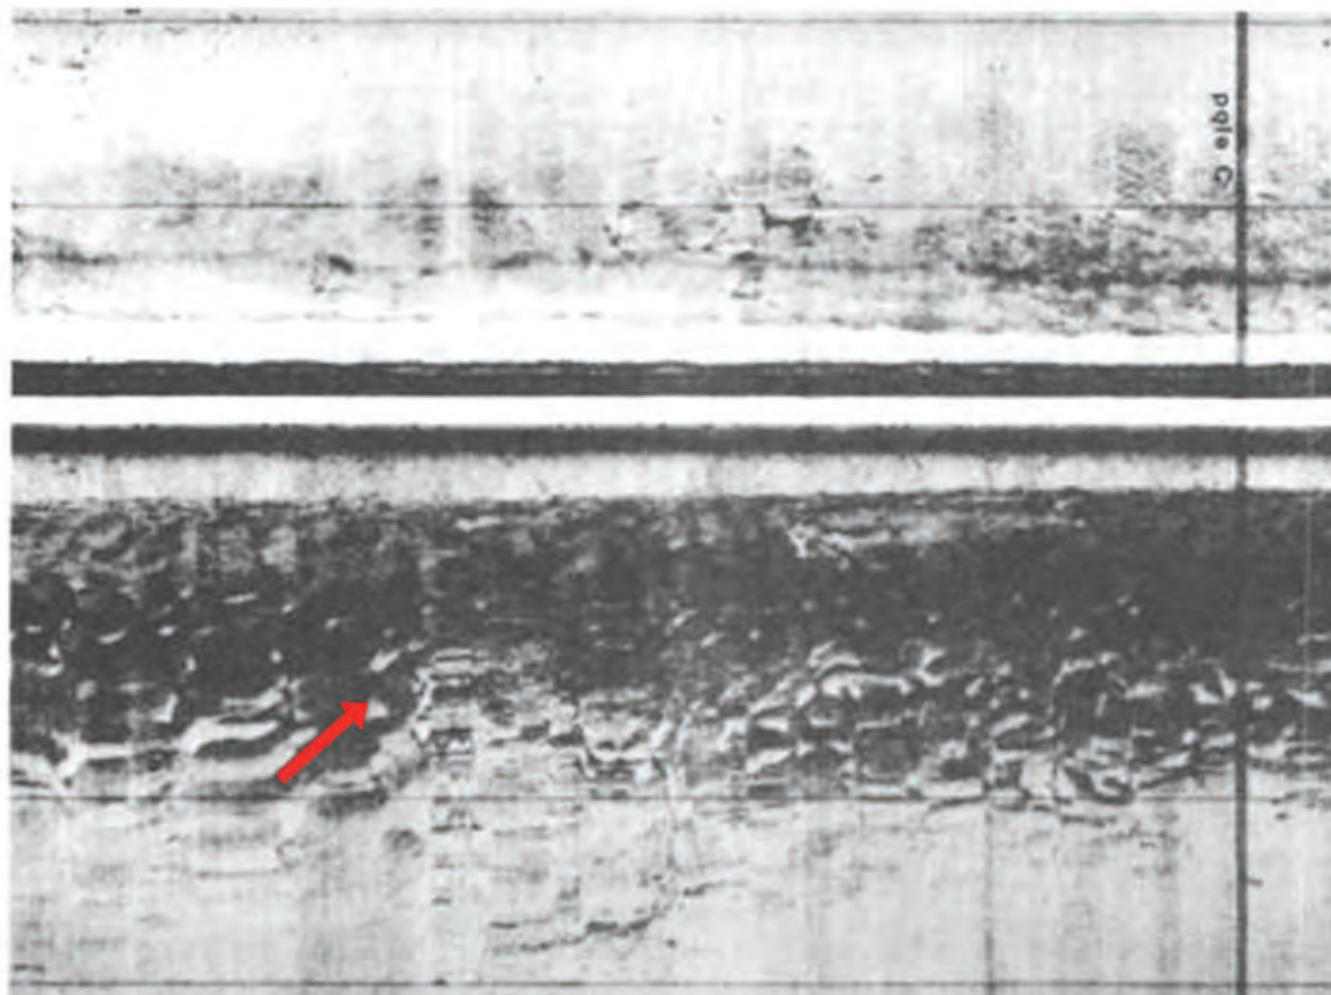
*It takes special training to interpret a side-scan sonar image! This one shows the pile of rubble that remains where a crib dam was near the upper rapids. Courtesy of the U.S. Army Corps of Engineers, Waterways Experiment Station, CERC-85-9.*

In the late 1800s, the U.S. Army Corps of Engineers removed the rocks forming the upper rapids to improve navigation. Later, the channel of the river narrowed in that area. To find out if any traces of the upper dam remained, researchers studied the area using side-scan sonar. That device was pulled by a boat. As the boat traveled, the sonar bounced sound off the river bottom and recorded a picture of the return signal.

Historical documents showed that three small dams had been at the upper rapids. The sonar survey confirmed that a part of one of the crib dams is still intact. However, there was no evidence of the other two dams, suggesting that they are no longer in place.
