Explore the Site

Upper Deck

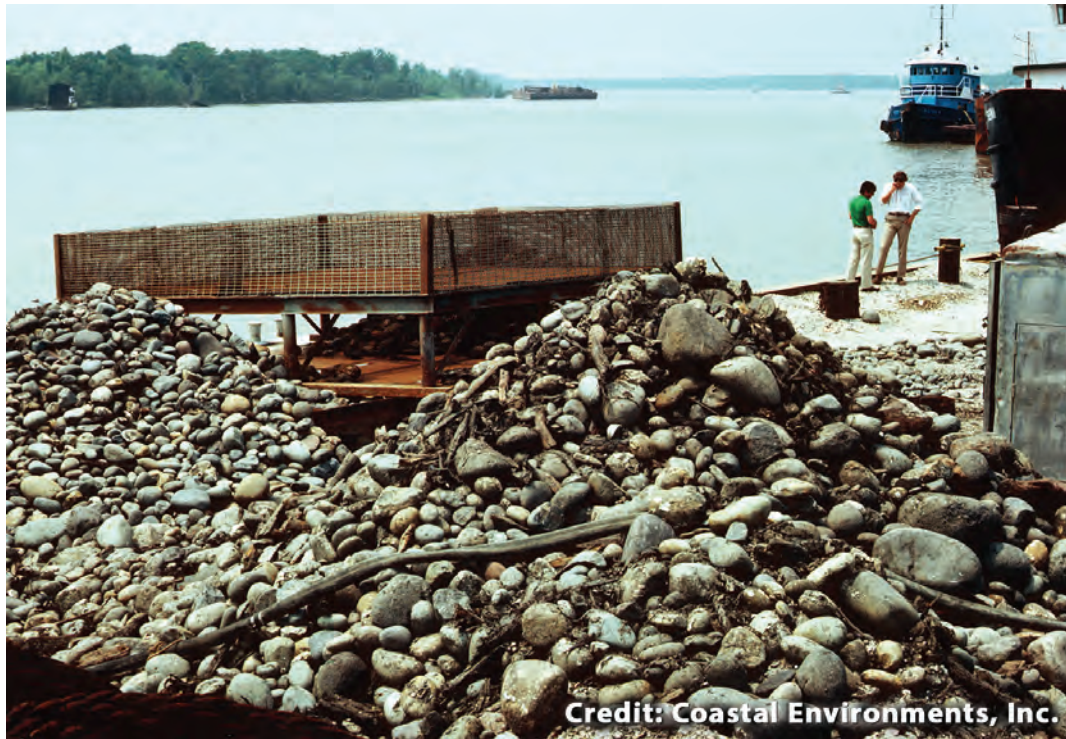
(Right) Cutaway view of ship showing where cargo and ballast were stored.

The ship had more than one level, as the illustration shows. The lowest one was carefully loaded with rocks and heavy cargo. This material, called ballast, helped keep the ship stable and upright. On *El Nuevo Constanste*, the copper ingots provided some of the ballast. To supplement this cargo, the ship also carried ballast stones. These smooth, rounded river cobbles were on board just to stabilize the ship. After the wreck, the people recovering the cargo may not have been able to reach the lowest levels, so the things stored there were left on the ship. Much of the cargo, however, was lightweight, and it was stored in a higher level.

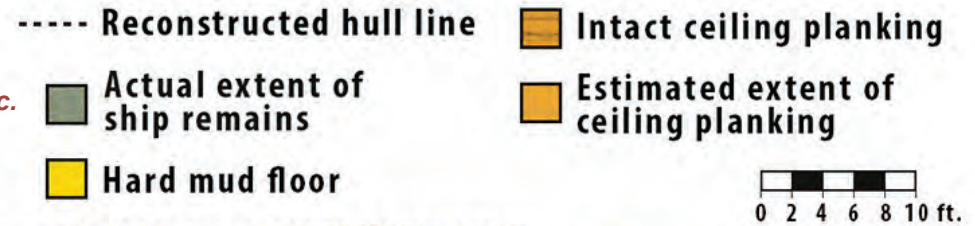
(Top right) Three cross sections show floor frame shapes required to achieve the curve of the hull. Credit: Coastal Environments, Inc.

The largest object recorded in the excavation was the lower 3 to 4 feet of the ship's wooden hull. It was 127.5 feet long and 26 feet at its widest point. The hull gave a lot of information about shipbuilding in the 1700s. Frame timbers averaged 11 to 13 inches in width. These were the large pieces that curve upward to form the ribs of the ship. Analysis showed that the frame timbers were oak. The large central timber, known as the keelson, was intact down much of the length of the vessel. One-inch diameter iron bolts attached it to the keel and other pieces. A large portion of the interior decking, or "ceiling" planking, also was still in place. Researchers identified samples of this ceiling planking as pine.

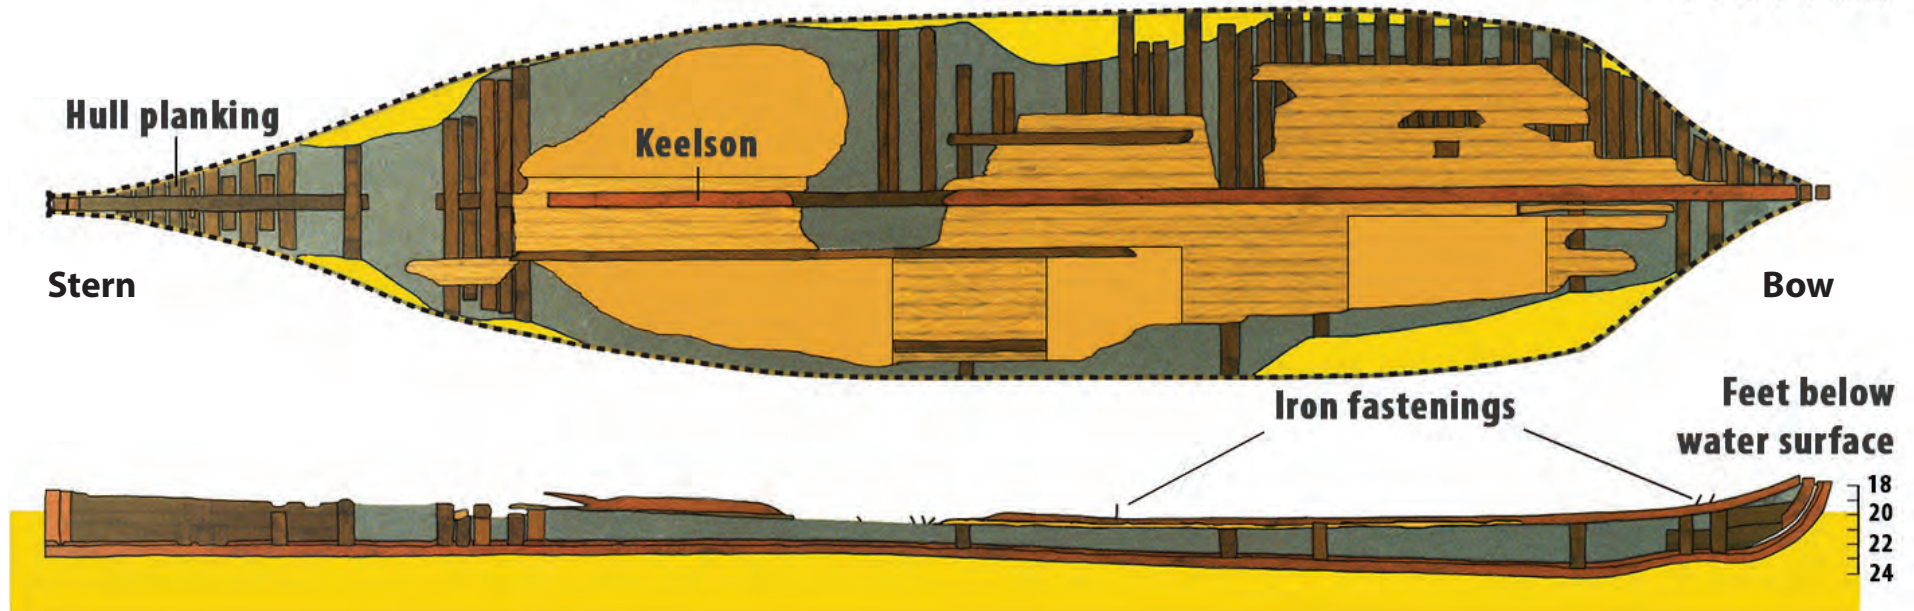
(Below) Schematic of the ship's lower hull. Credit: Coastal Environments, Inc.

Wooden planks covered the outside of the ship. These planks were 4 inches thick and up to 13 inches wide. Wooden pegs, called trunnels, and iron bolts attached the hull planks to frames. The pegs were approximately 1.75 inches in diameter. Analysis showed the hull planks and pegs to be made of white oak.

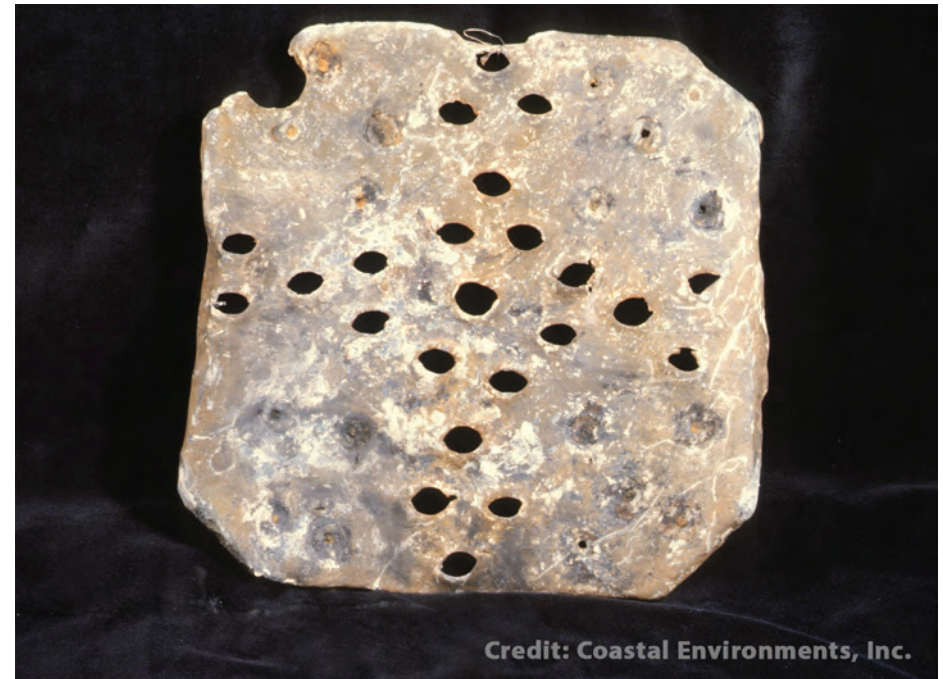
(Top) Lead strainers like the one seen above were used to strain debris that could clog the ship's bilge pumps. Bilge pumps were used to pump water out of the ship.

Divers recovered two bases of wooden bilge pumps from the middle part of the ship. They were found on either side of the keelson. This was the typical location for pumps on ships of this size. The pieces are the bottoms of the long pump shafts that extended from the low, inner part of the hull to an upper deck. The outside shape of each shaft is hexagonal, and the central, circular hole is 3.5 inches in diameter. They are made of elm. Each specimen has a lead screen nailed to the base.

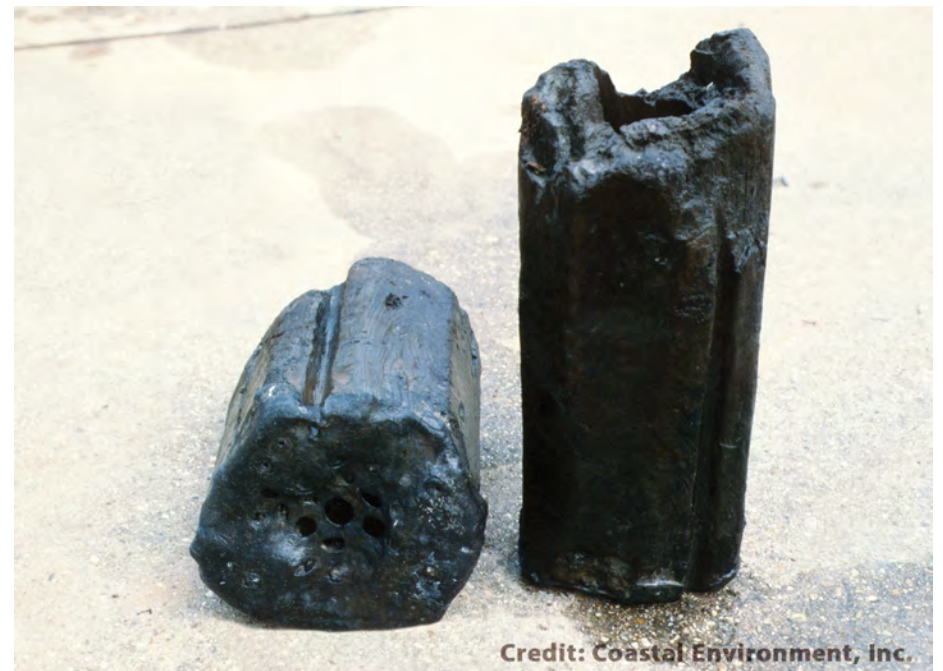
(Bottom) The lead screen can be seen on the base of one bilge pump (left) and the circular hole can be seen in the center of the other (right).
