Historic Resources Survey

for the City of Slidell, Louisiana

Report

June 2017

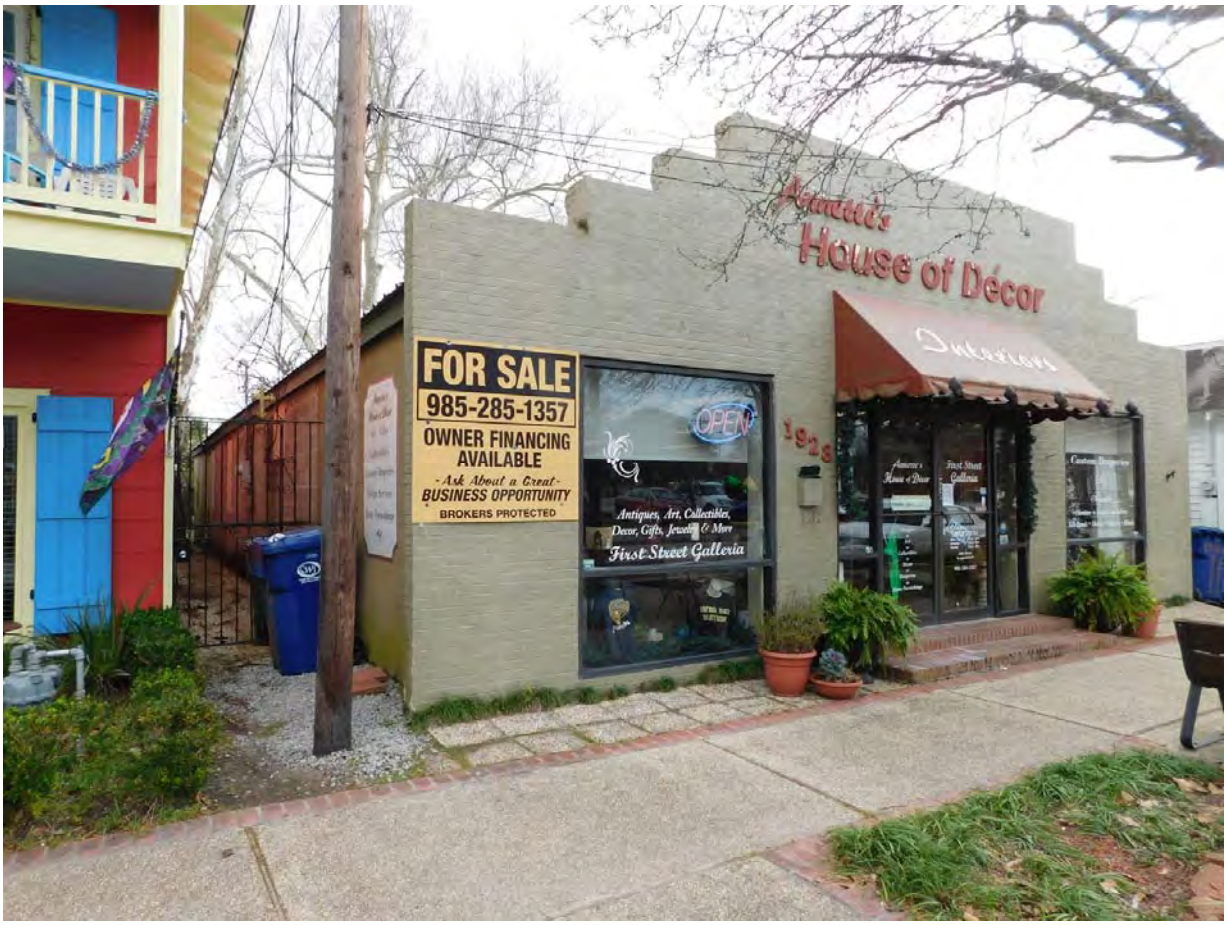
NOTED ALTERATIONS

Wall cladding replaced
Windows replaced – all
Door (primary) replaced

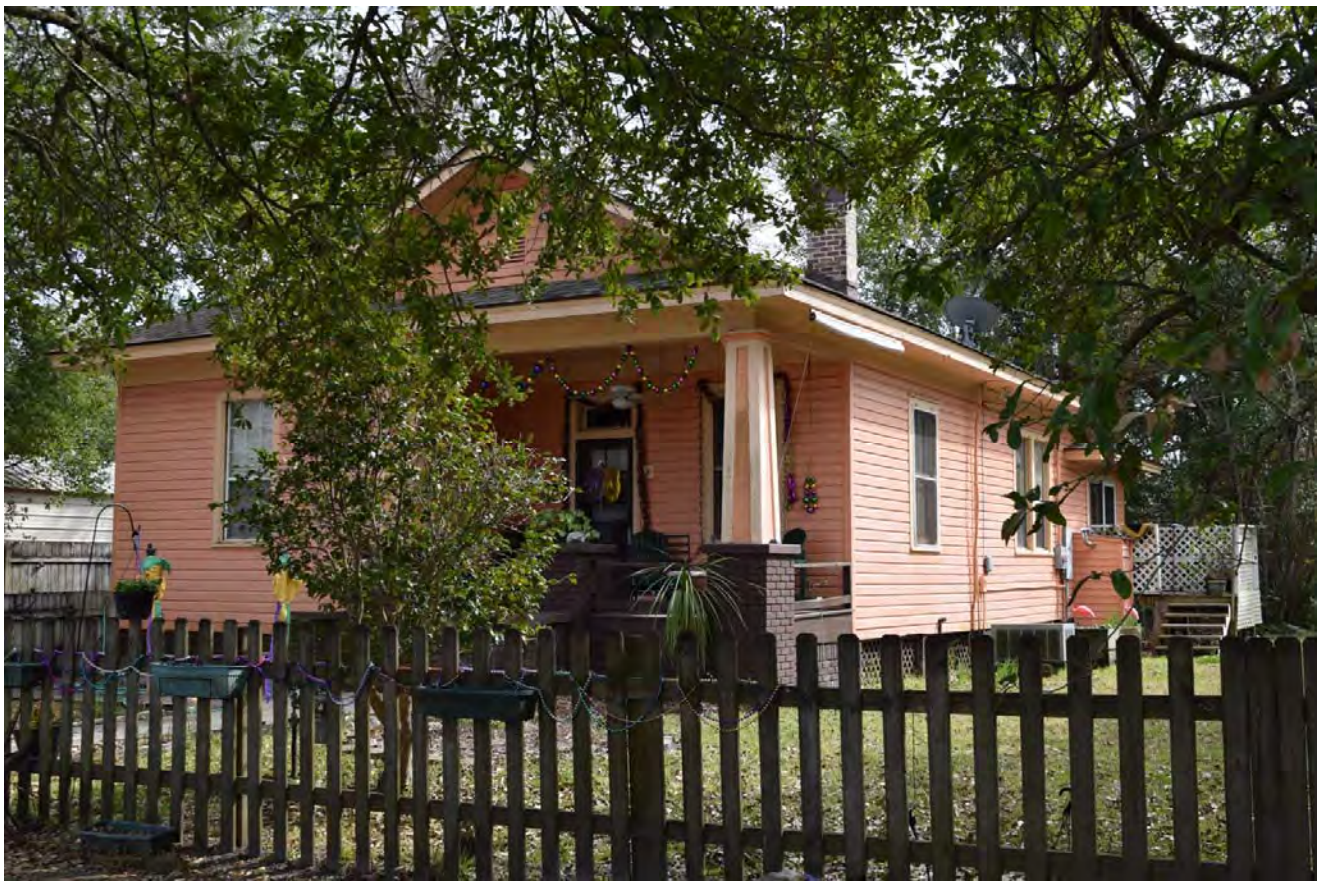
NOTED ALTERATIONS

Converted from multi-family to single-family residence
